BORE POLISHING IN A RUNNING DIESEL ENGINE

A thesis submitted for the degree of

SEPTEMBER 1982

Lubrication Laboratory  
Department of Mechanical Engineering  
Imperial College of Science and Technology  
London SW7 2AZ

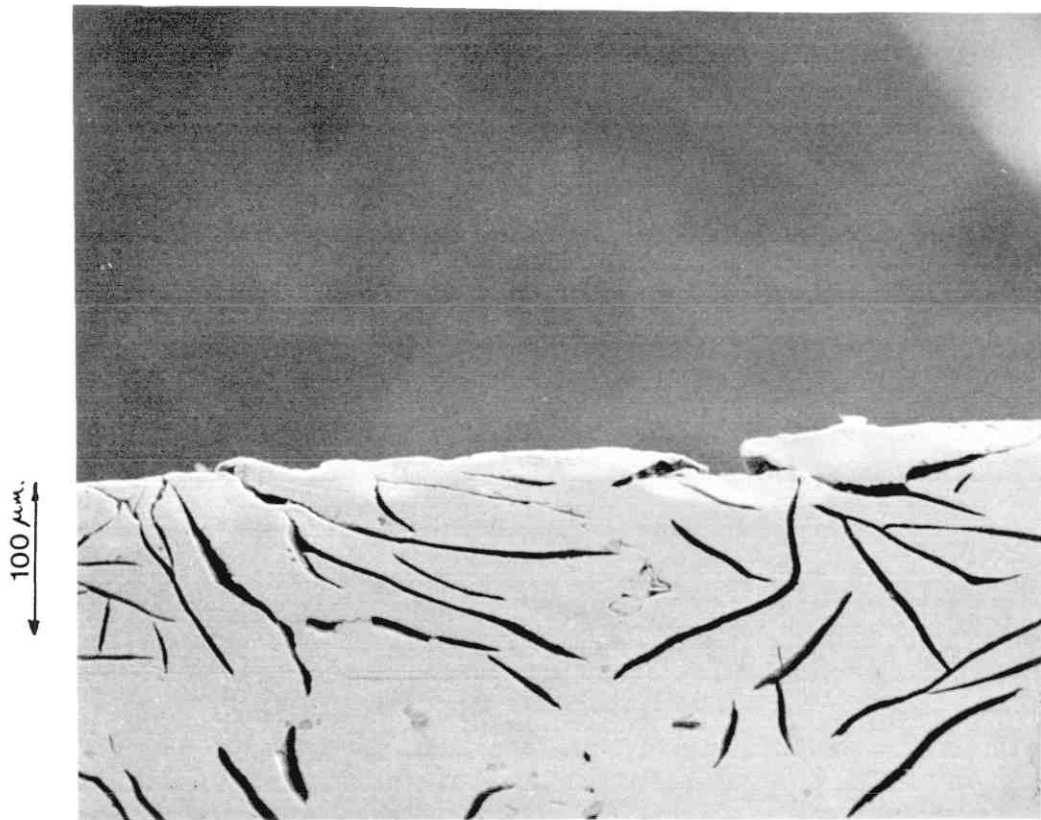
Figure 5.32 Transverse Micro-section of Liner with B2+0.75%C(<sup>w</sup>/w) at 250°C(Drip Feed). (200x)

As in previous microstructural studies in this thesis the heavily polished liner has clearly greater subsurface deformation than the non-heavily polished liner. There was no evidence of a white layer, glaze or 'filling-in' process on any liner examined. It is clear, again, from this investigation that heavy polishing is a high stress process, producing greater deformation than that observed for non-heavily polished liner specimens.

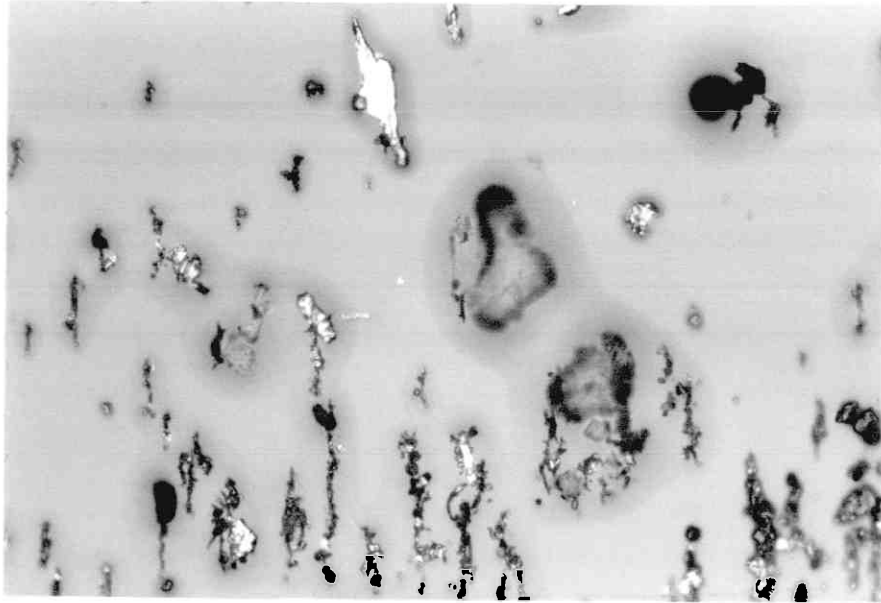
Figure 5.37 Optical View of Ferrogram. B2+1%C(<sup>W</sup>/w) at 250°C  
(immersed) (440x)

The ferrographic analysis has shown that a wear debris similar to delamination wear particles has been observed as well as probable cutting wear debris. A number of small metallic particles were observed and could be the cause of the abrasive cutting wear particles. These small particles could be formed from disintegrated platelets or could be corrosive wear debris.
